Lucas 4CU Fuel Injection

Gene Thompson

1980/1981 Triumph TR8 Fuel Injection System

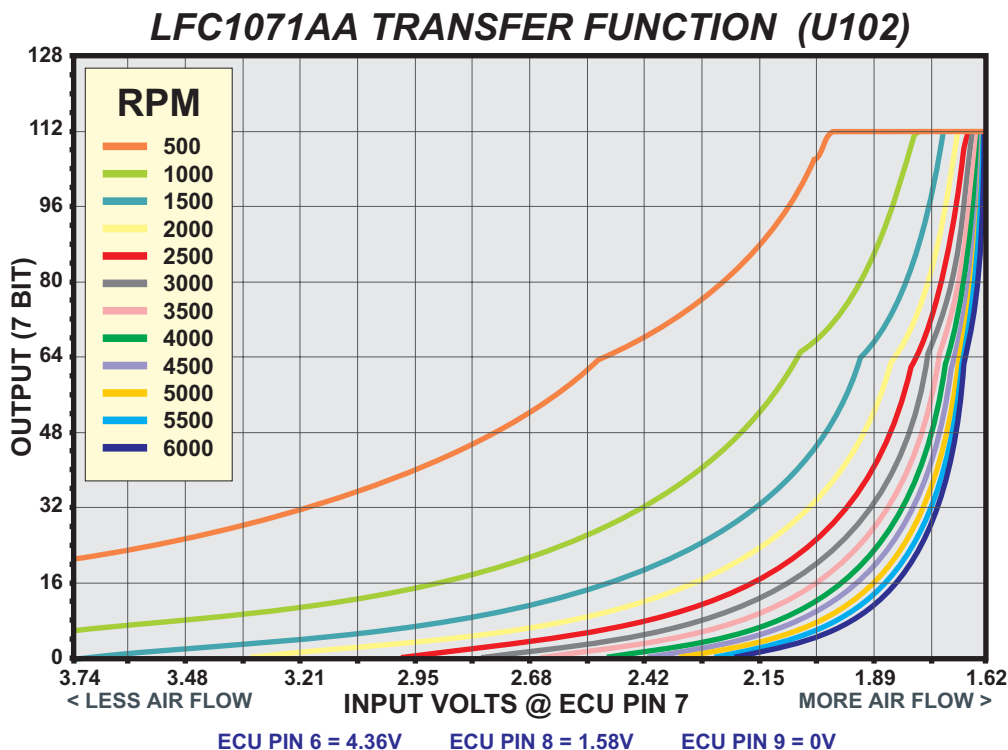
The following graph shows what the analog-to-digital converter chip does. It reads the air flow meter and tachometer signals and derives a 7 bit number that represents engine load, acting as a "virtual vacuum gauge". Coasting downhill with a closed throttle outputs a low load number (high RPM with little air flow), while wide open acceleration causes higher air flow at a lower RPM and outputs a high load number. I don't know why it only goes to 112 instead of 127 – one of these days I'll re-run the test.

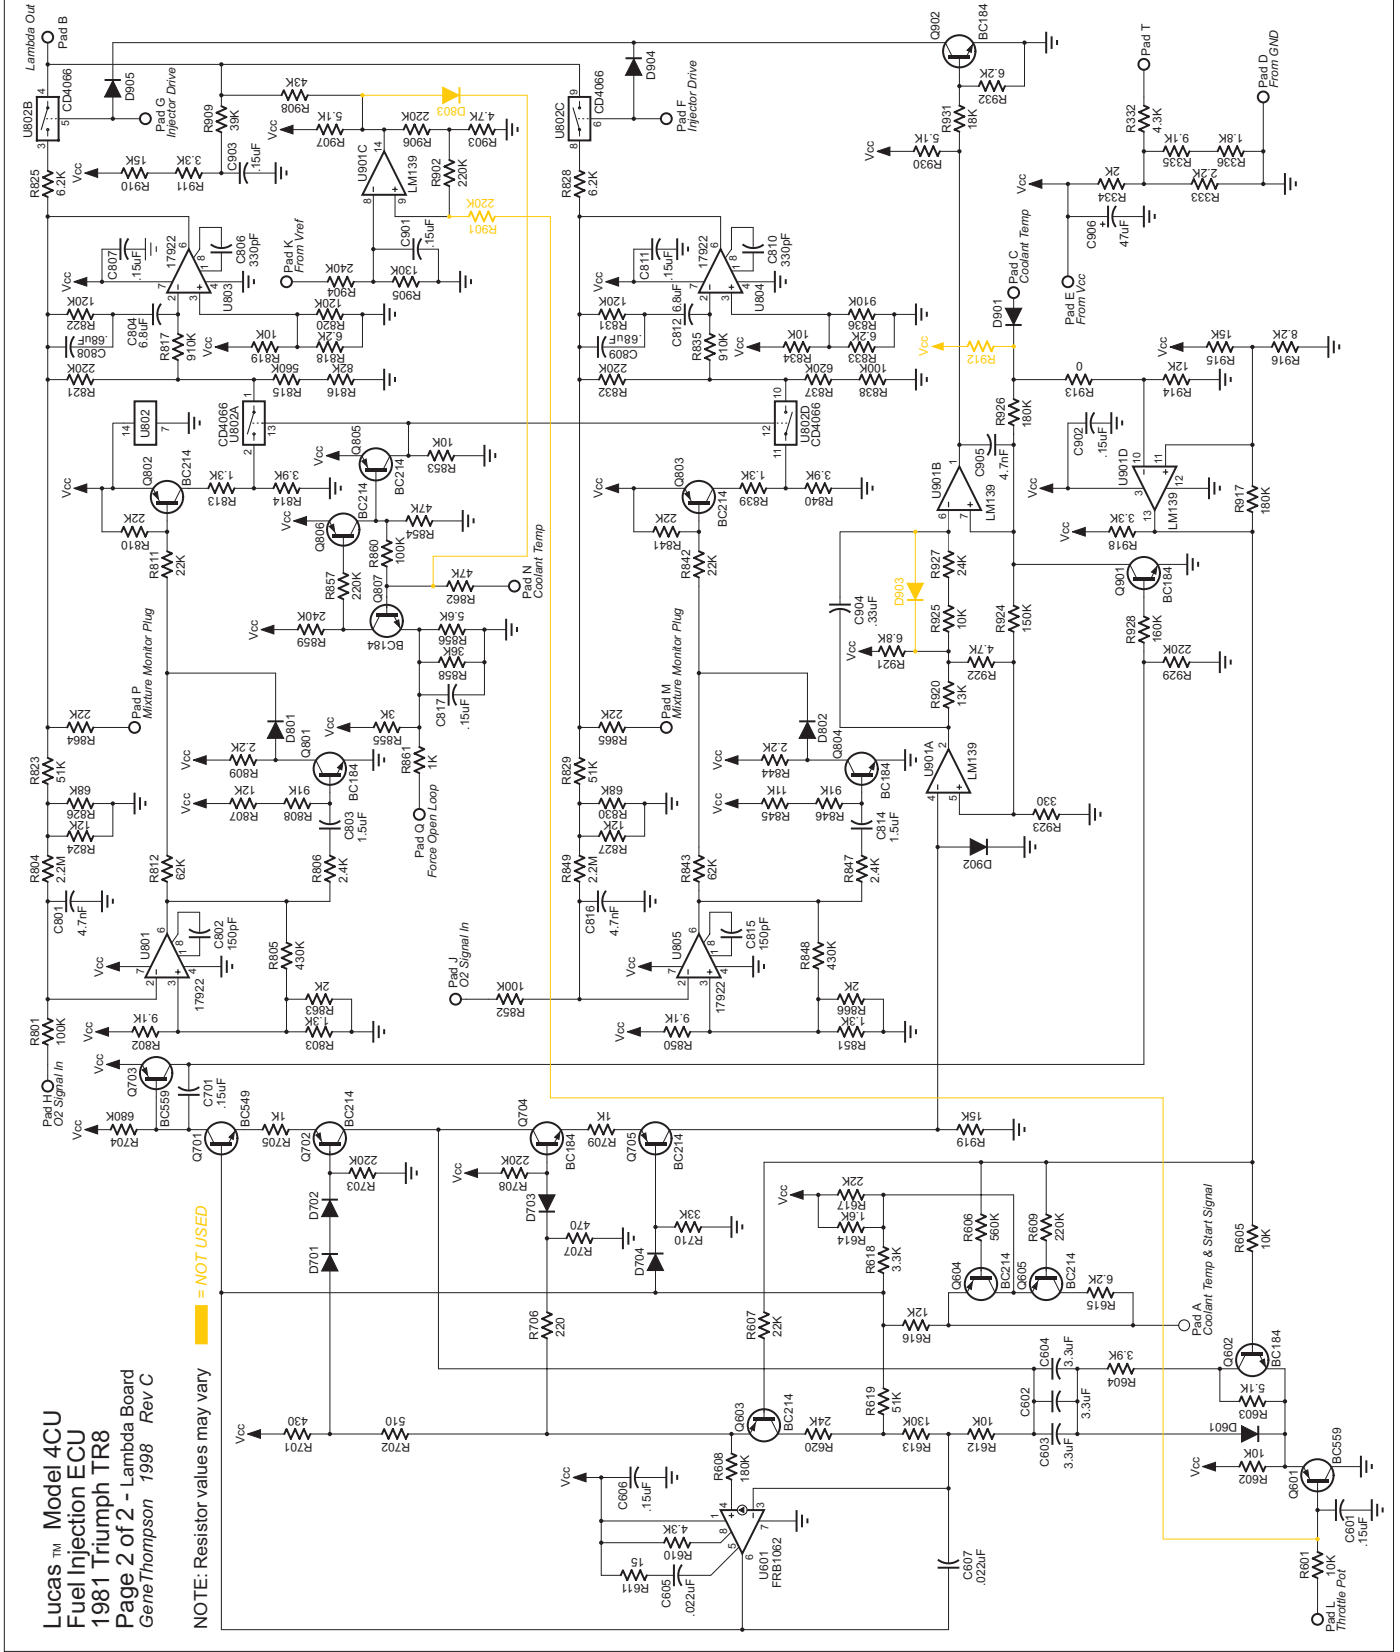
U.S. TR8/SD1 Lambda Board

Lucas™ Model 4CU
 Fuel Injection ECU
 1981 Triumph TR8
 Page 2 of 2 - Lambda Board
 Gene Thompson 1998 Rev C

The enrichment signal developed on the lambda board is labeled "lambda out" on the schematic. In closed loop mode it is pulled toward Vcc by R909, R910 and R911 and pulled toward ground by the open collector output of U901C through R908. The lambda sensors contribute their opinion through R825 or R828. In open loop mode, the enrichment signal is pulled closer to Vcc by R907 and R908 in parallel with R909, R910 and R911. Judicious adjustment of the resistors can tailor the response as needed.

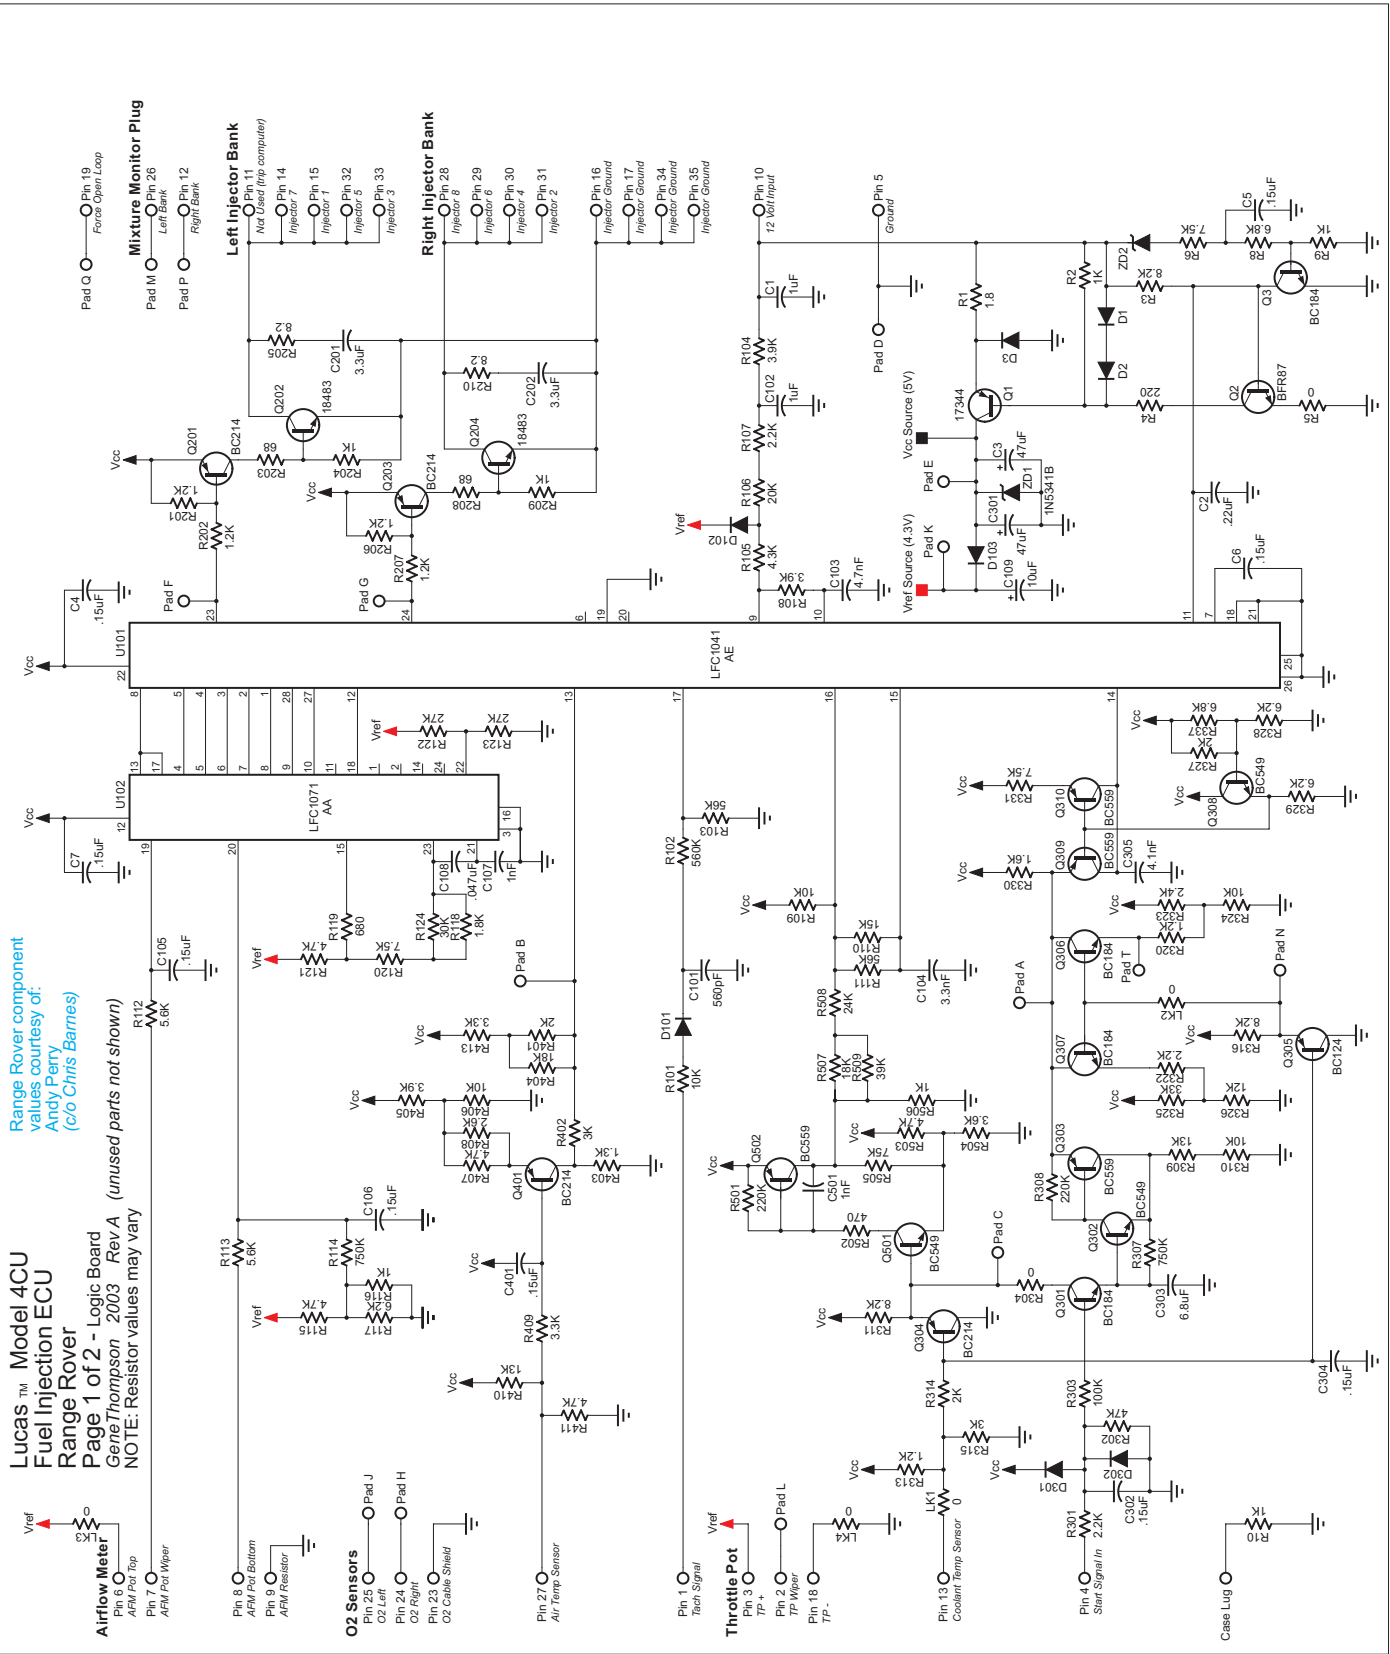
U.K. SD1/Range Rover Logic Board

Lucas™ Model 4CU
 Fuel Injection ECU
 Range Rover
 Page 1 of 2 - Logic Board
 Gene Thompson 2003 Rev A (unused parts not shown)
 NOTE: Resistor values may vary

- Many non-US SD1s and Range Rovers (until '89) use a version of the the 4CU ECU with the lambda circuit components removed from the circuit board. Additionally, they use a circuit to enrich the mixture at throttle openings greater than 75%. The US 4CU includes all the required components except one - R901. Putting a 220K resistor in for R901 should give extra enrichment at full throttle. If D803 is added, the ECU will switch to open loop operation at full throttle as well.

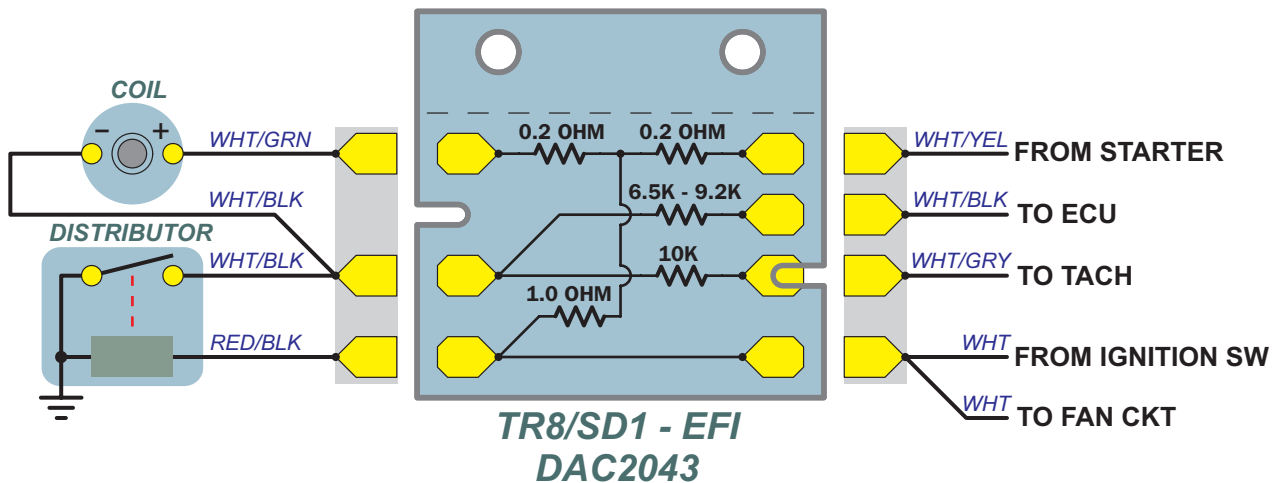
TR8 Ignition Ballast

TOP VIEW - AS INSTALLED

The stock ignition setup uses three resistors in various combinations to accomplish what most cars do with one. The resistance of each is less than normal, so if care isn't taken when installing aftermarket equipment, the coil may overheat and die when you're out in the middle of nowhere. When it cools down, it starts working again. It may take your new distributor with it, too.

The ECU needs to get a proper signal back from the coil. Even if a non-ballasted coil is used, the tach and ECU should get their signals from the extra resistors inside the ballast unit. You can substitute good quality discrete resistors if you just can't stand looking at the stock unit. The resistors reduce the amount of electrical noise radiated into the wiring harness by the coil. See the ballast schematic on page 13 of this document.
